Manhole Inspection Summary

Manhole # S33CC_007MH

Insp Date: **4/17/09 2:23 PM**

Location Address: **1001 N. CHARLES ST**

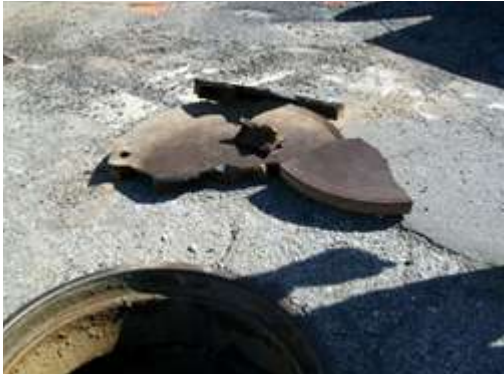
Miscellaneous

Comments **BROKE AND REPLACED COVER**

BROKE AND REPLACED COVER

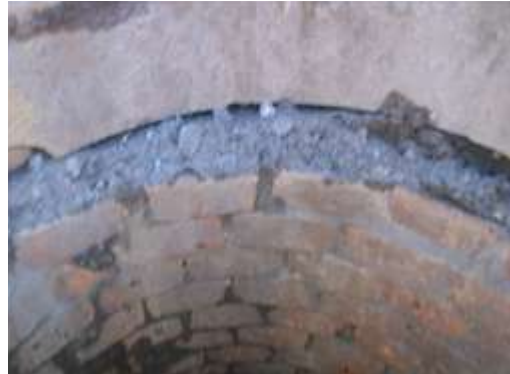
Defect 1

Offset: **1.5** (in.)

FRAME OFFSET

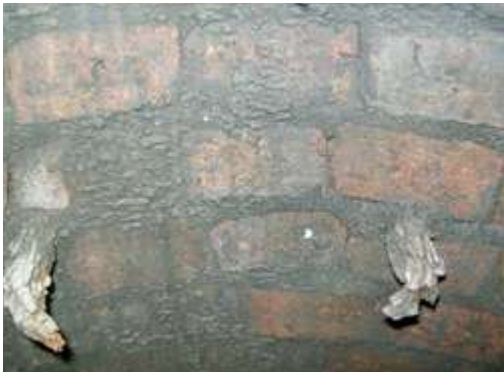
Defect 4

Missing: **4**

☒ **Corroded**

CORRODED/MISSING STEPS

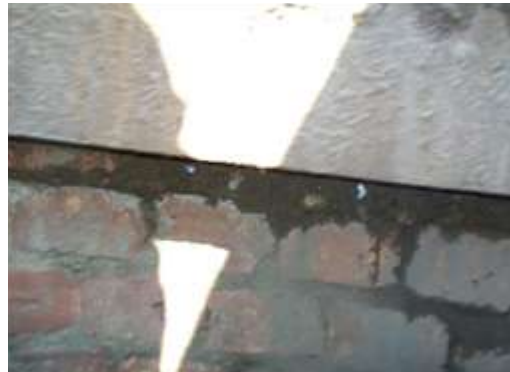
Defect 3

☒ **Joint**

INFILTRATION @ CORBEL/FRAME JOINT

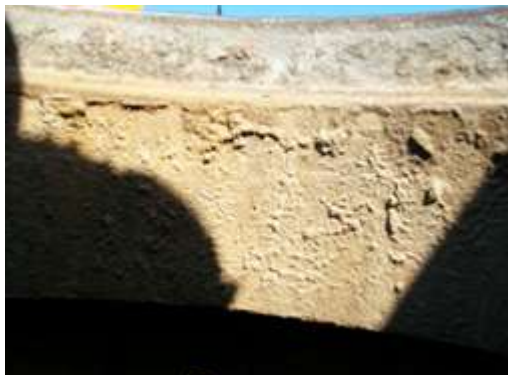
Defect 2

☒ **Leaks**

FRAME LEAKS

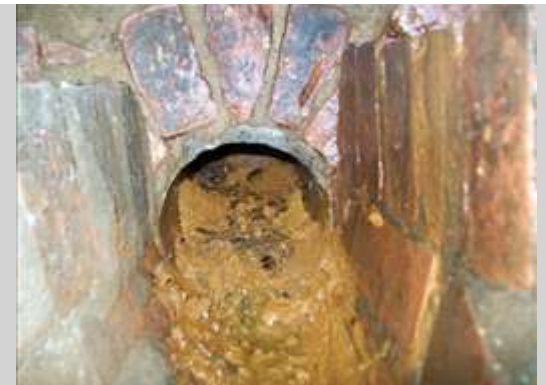
3 O'Clock Inflow

0 in. Circular Gravity Sewer
Pipe In @ 3 O'Clock

Pipe Height: **0** (in.)
Pipe Material: ☐ Pipe Lined
Invert Depth: **0.00** (ft.) Flow Characteristics:
Deposits: ☐ None ☒ **Mud** ☐ Sludge ☐ Debris ☐ Grease
Silt Depth: **0** (in.) Deposits Extent: **Heavy**
Infiltration: Pipe Seal Cond:

Connects To: **Stub connection / abandoned**
